Failure Analysis of an Ice Detector on the Austria 13 Helicopter

Manning Stelzer

**CURE / Engineering
Sikorsky Aircraft**

April 30, 2004

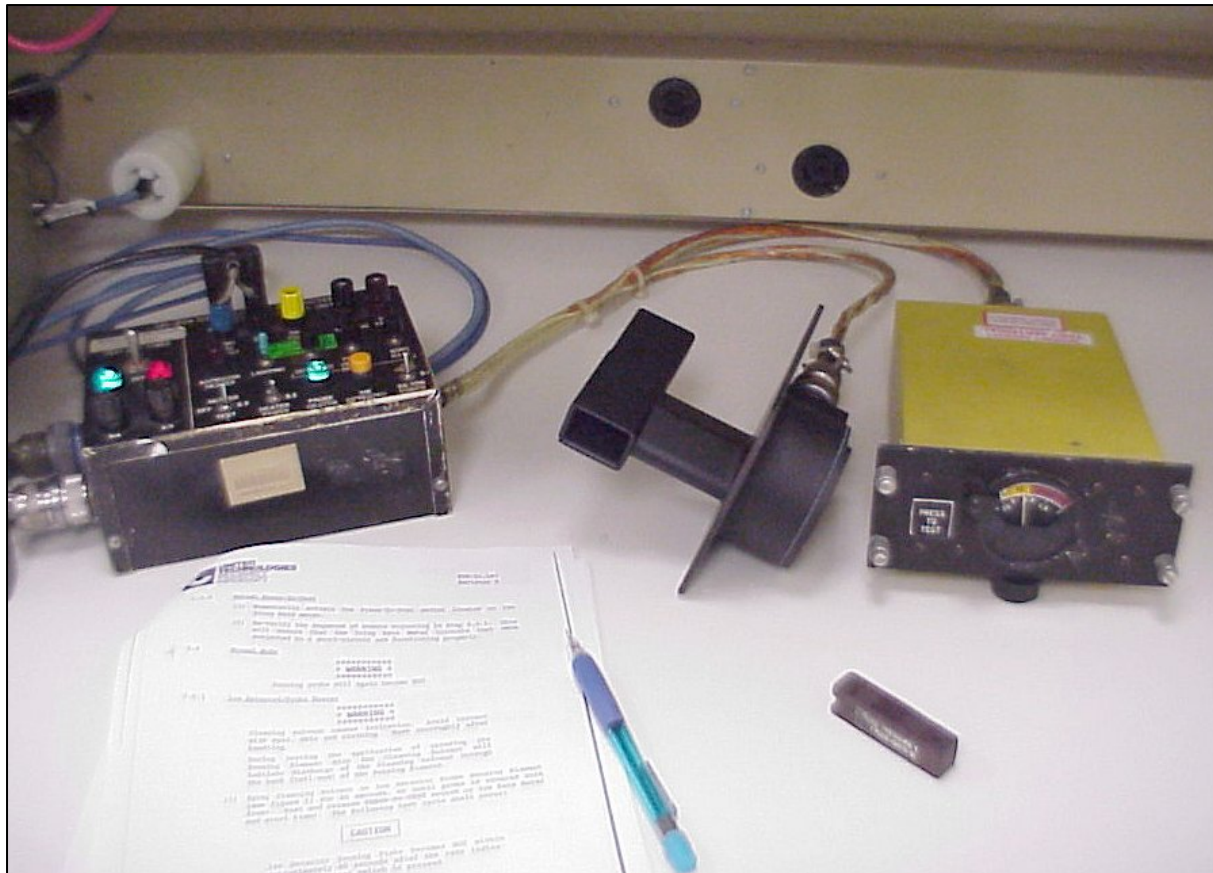
Bench testing in Sikorsky QA Lab confirmed the malfunction during performance of the Austria 13

Failed step 5.4.1: Probe heater of ice detector

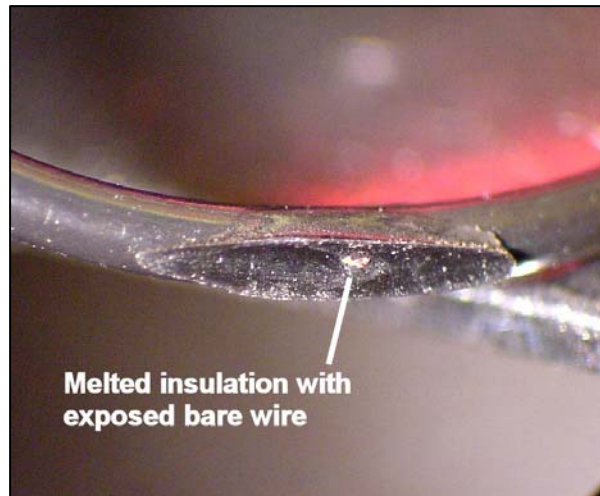
Melted insulation with exposed bare wire

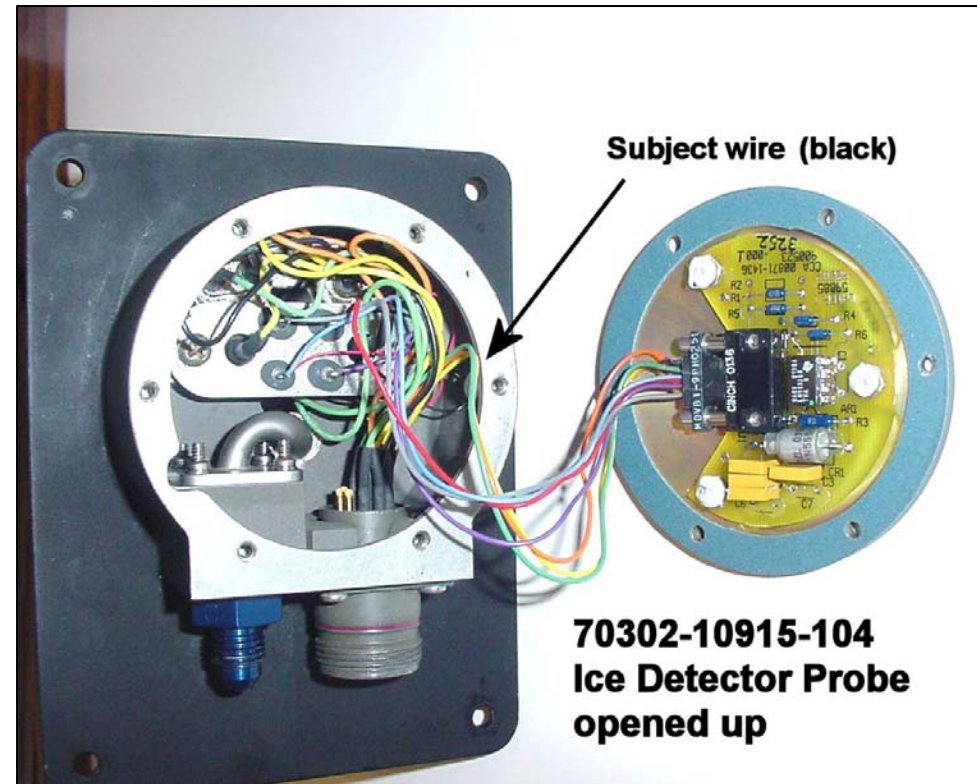
Teardown examination revealed uncontrolled location of interconnecting wires

Wires were not tied into harnesses

Final positions of wires in assembled unit cannot be controlled or inspected

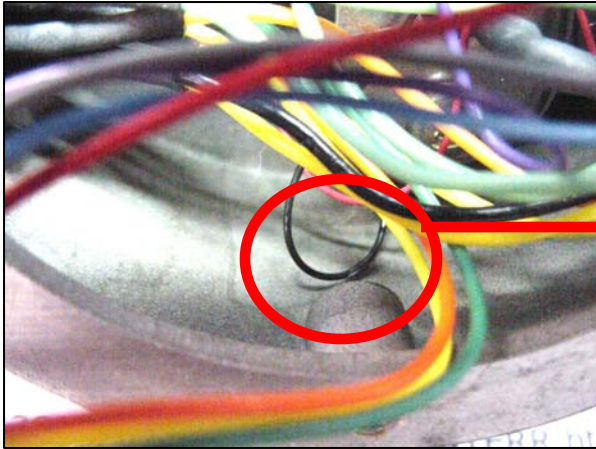
Close examination revealed wire in contact with housing and exposed wire at point of contact

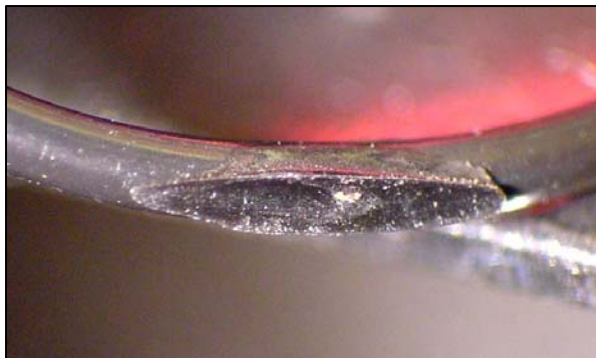
Photo shows that wire in contact with housing

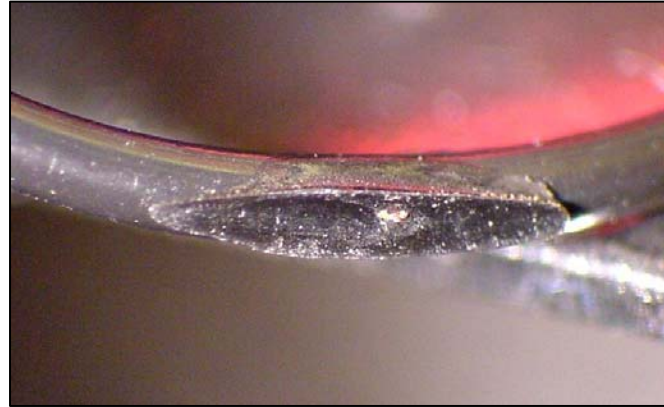
Microscopic photography reveals abraded insulation

Abraded wire insulation exposing conductor

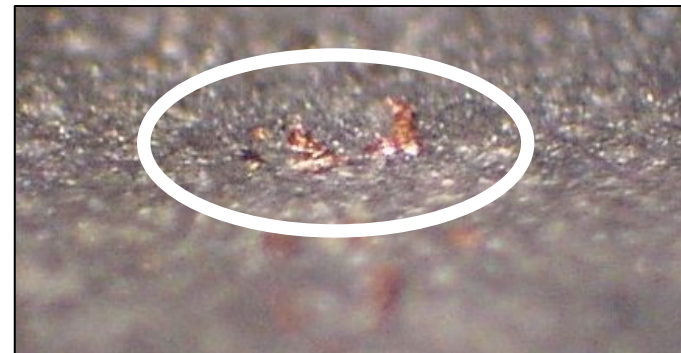
Material transferred from conductor to housing confirms abrasion and therefore short circuit

Copper from wire transferred to housing at point of abrasion

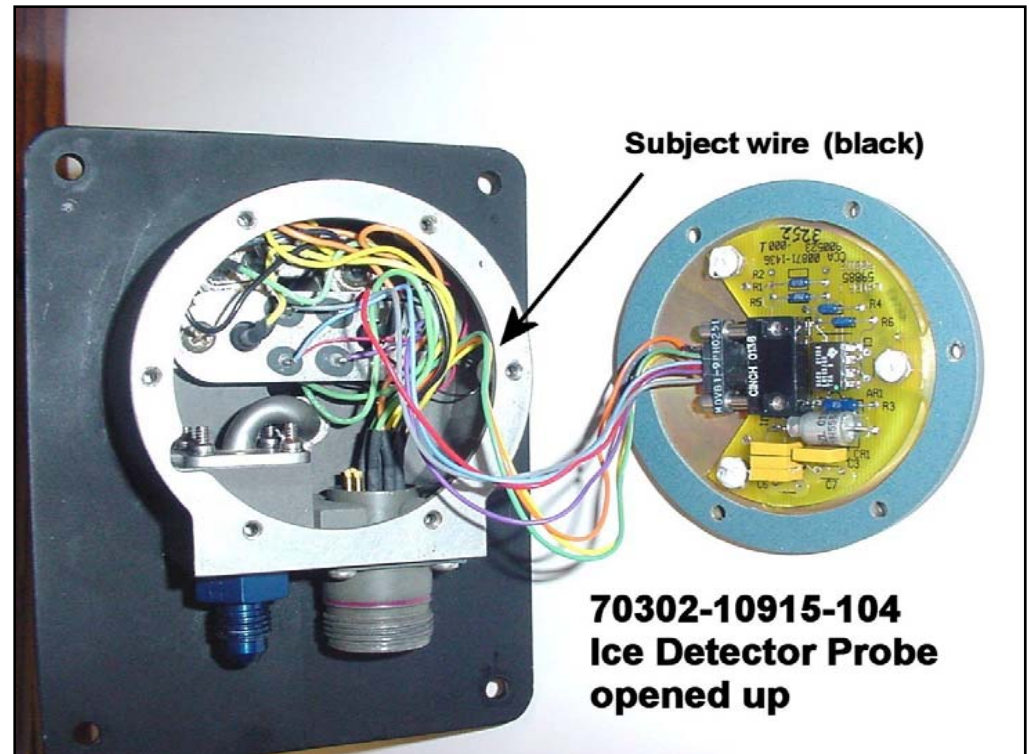
In summary, the unit failed because of a short-circuit created by abrasion of wire insulation

Wires not harnessed to prevent contact with housing

Wire abraded against housing, exposing conductor

Short circuit to ground created where wire contacted housing
